## **District 5**

# PRIMARY RECORD

Resource Identifier: Alma Forest Fire Station

- P10. Report Citations:** (Provide full citation or enter "none") A Survey and Historic Significance Evaluation of the CDF  
Building Inventory, 1994 Mark V. Thornton

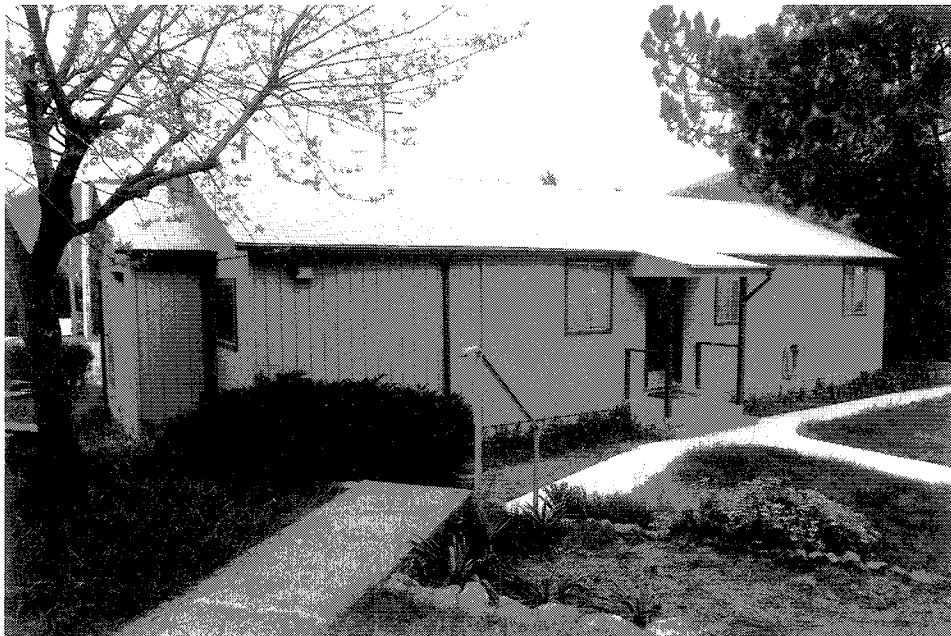
This fire station includes a 1935 barracks, a 1935 combination kitchen-messhall, a 1935 equipment garage, and a 1935 gas and oil house. The buildings were moved from the old Alma Ranger Unit Headquarters to the present site in 1953. The 1,782 barracks is a single story wood frame building. It has a concrete perimeter foundation, plywood panel siding, 1/1 aluminum frame sliding windows, enclosed eaves, and asphalt composition shingles over a cross-gabled roof. The building has a rear facing "L" floor plan. Concrete steps and landing lead to the front door which is centrally located on the southeast elevation. The entry is shaded by an extended shed roof. Two posts support the porch roof. A 4' x 18' gable roof bay is on the northwest gable end of the front wing. The bay is off-set to the left end of the wall. The bay is part of a 16' x 25' addition that was added to this end of the barracks. A rear entry is recessed in a small alcove on the northeast wall of the addition. Redwood steps and a small deck front this alcove entry. Centrally located (eave side) on the southeast elevation of the rear wing is a dropped shed roof. A small utility closet and side entry are protected by this roof. The shed roof overhanging the side entry is supported by a wood post on the northeast end. Another door is to the left of the utility closet, being on the southeast gable end of the front wing. (See continuation page)

Southwest elevation of the barracks.

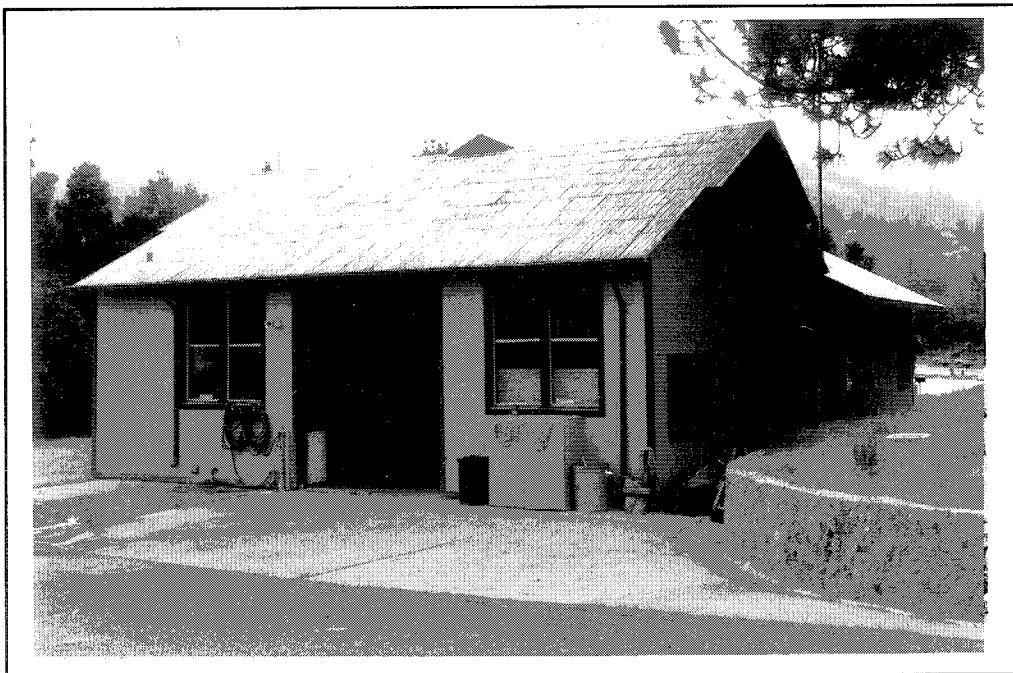
The 2,442 square foot rectangular equipment garage has a concrete slab foundation, plywood panel siding, fascia, and corrugated metal paneling over a tri-gabled roof. The building consists of two sections. The gable front wing is a combination office and two stall truck garage which was constructed circa 1969. The rear wing is a one stall garage between two storerooms. The rear section was moved here in 1953. The building has a "drive through" floor plan. The front wing's gable end vehicle entries have overhead aluminum sectional doors. To the left is the office door which is shaded by a cantilevered shed roof. The addition has 1/1 aluminum frame sliding windows on the northern and western elevations. The original section of the garage has five large 1/1 fixed pane windows centered on the south gable end. A 1/1 double hung window is centered on the north gable end being flanked by paired 1/1 wood frame sash windows. The single stall rear entry (added circa 1969) is centrally located on the east elevation (gable side). The entry is flanked on each side by a pair of large 1/1 fixed pane windows. Louvered attic vents are located in each of the three gables.

East and north elevations of the equipment garage.

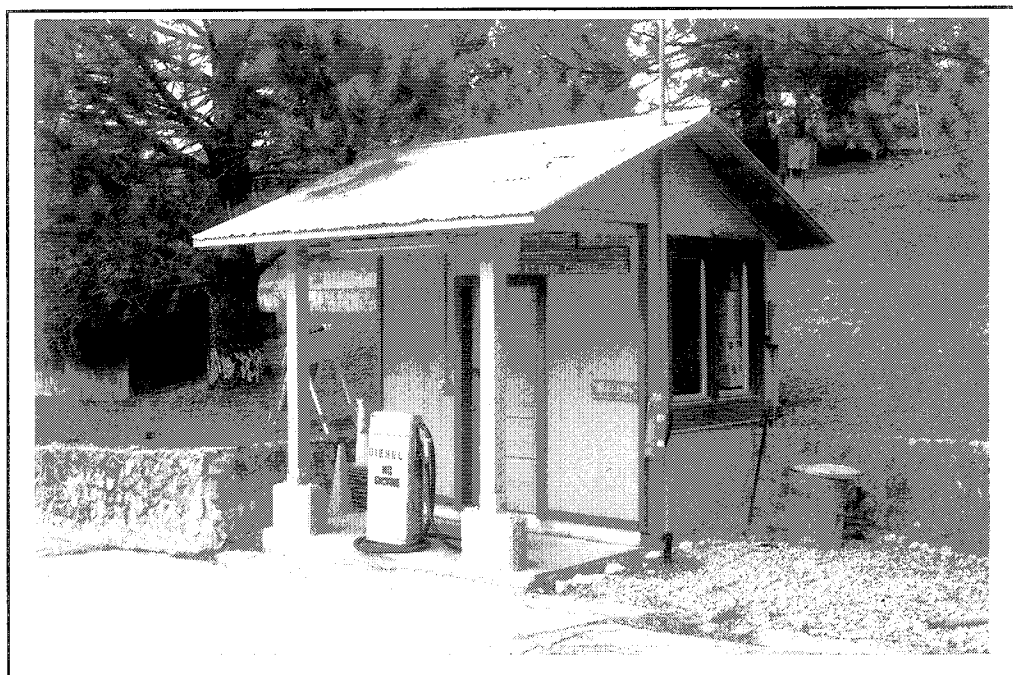
The gas and oil house has a concrete slab foundation, plywood panel siding, plain fascia, and corrugated metal over a simple gable roof. Recessed under the south (gable side) elevation is a concrete fuel pump island. Two wood posts provide support for the unbalanced gable roof. A five panel door is centered on this elevation. A 1/1 window is located on the east gable end. A three foot high rock retaining wall runs behind the gas and oil house extending on behind the neighboring equipment garage.

South and east elevations of the gas and oil house.

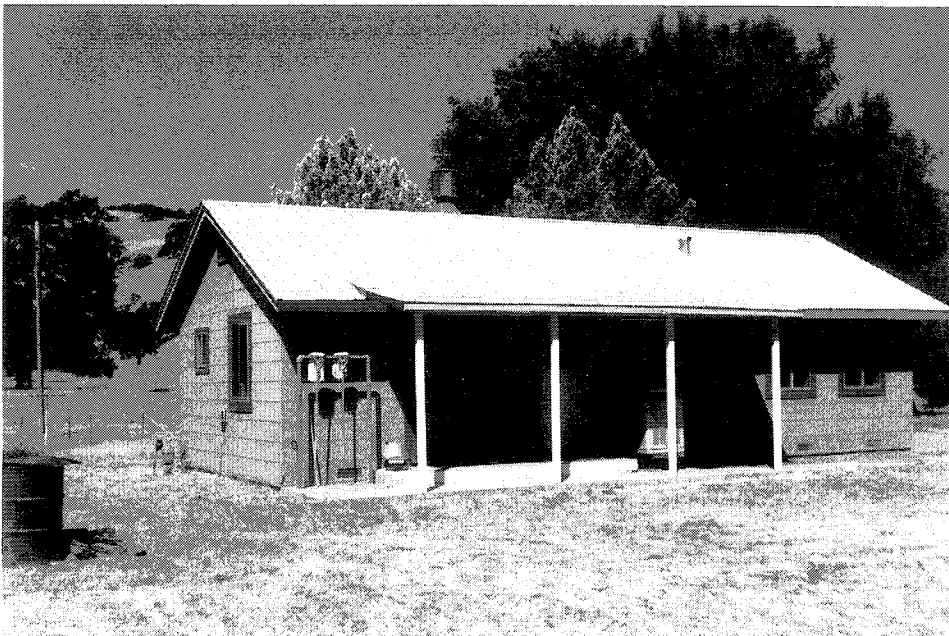
The combination kitchen-messhall at this site was constructed in 1945. The 720 square foot building has a concrete perimeter foundation, asbestos cement tile siding, 1/1 aluminum frame windows predominate, enclosed eaves, and asphalt composition shingles over a gable roof. A small shed roof centered on the north gable end covers a 6 light/1 panel door. A shed roof supported by four wood posts covers a concrete slab porch and side entry on the east elevation. The southern door on this elevation has an outer aluminum frame screen door. The other door on this wall features a 6 light/1 panel design. A five panel utility door is on the west elevation. The wall to the left of this door has a 1/1/1 aluminum frame sliding window flanked on the left by two 1/1 aluminum frame sliders. Louvered attic vents are located in each gable end. A 1948 gas and oil house, a 1949 equipment garage, and a 1972 barracks are also located on the compound. Trees have been planted around the perimeter of the station compound with additional landscaping around the messhall and barracks buildings. A 1948 well pump house is about 200 feet to the north of the station. The station is on level ground. The surrounding area is predominate in oak woodland and open range.

South and east elevations of the combination kitchen and messhall.

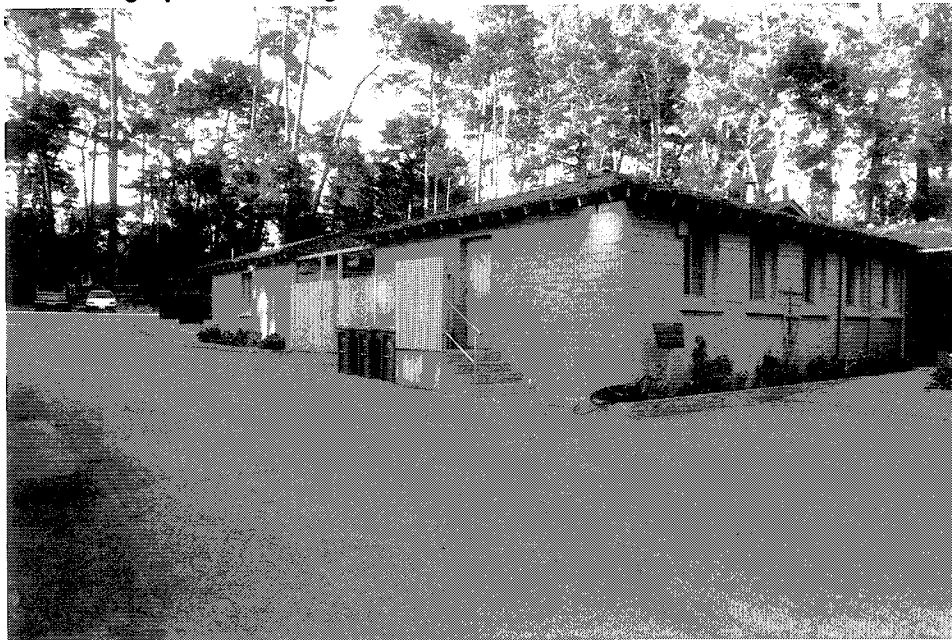
Two of the adobe brick buildings at this site were erected in 1943-44. The 3,624 square foot combination barracks is a single story building with a concrete slab foundation, 1/1 aluminum frame sliding windows predominate, open eaves, and wood shingle roofing. The original building consists of a symmetrical front facing "U" floor plan with a 20' x 12' rear hipped wing opposite the front left wing. Recessed under the roof of the rear wing is an 11' x 8' screened porch. The front wings are hipped and the connecting wing has a gable on hip design. The small gables are on the ridges of the front wings and serve as louvered attic vents. Inset in the "U" and recessed under the principal roof (of the central wing) is a 15.5' x 8' stone patio. The front door is off-set to the left end of this patio area. Two wood posts with matching pilasters on the front wings support the roof overhang. The balance of the space between the two front wings has an uncovered 20.5' x 15.5' concrete patio. Spanning the distance between the front wings in front of the patio is a six foot tall wood fence. A wood fence has also been erected in front of the right front wing's centered entry door. Circa 1980 a 16' x 20' concrete block hipped wing was constructed on the north elevation and a 12' x 25' concrete block right rear wing was also added. A covered breezeway on the south elevation connects the combination barracks to the equipment garage. (See continuation page)

Southwestern (front) elevation of the combination barracks.

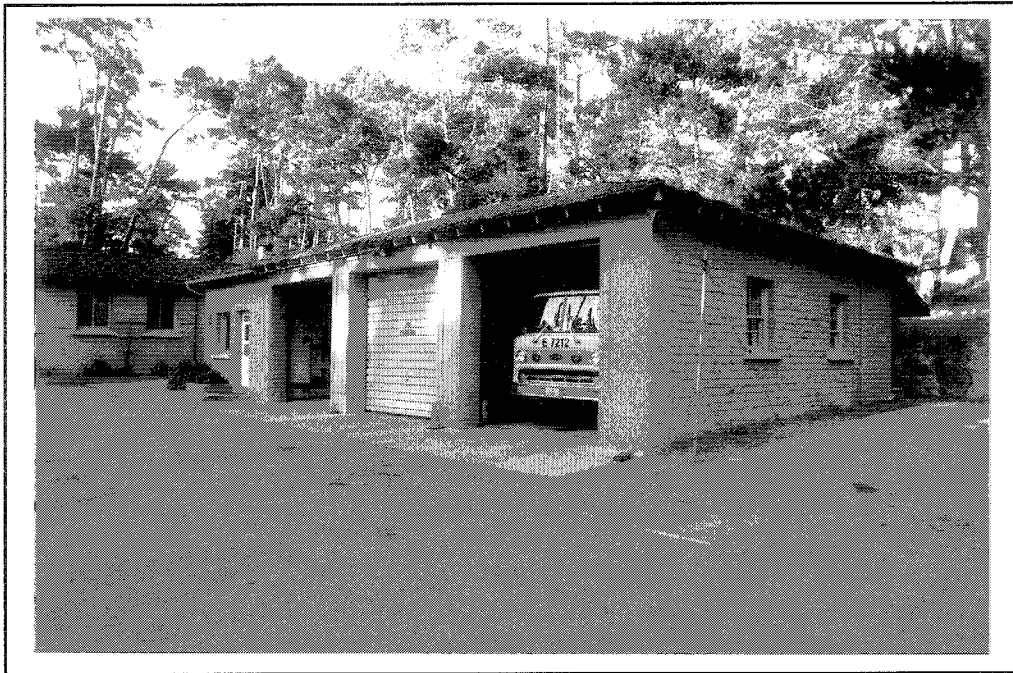
The 1,664 square foot equipment garage is a single story rectangular building with hip roof. It has a concrete slab foundation, open eaves, and wood shingle roofing. Windows are a mixture of original vintage 4/4 wood frame double hung types and 1/1 aluminum frame sliders (sills are cement). The north end of the building serves as an office. The three vehicle stall entries have overhead sectional doors. Bay jambs are of poured concrete with decorative rectangular inset panels. A dropped shed roof on the rear elevation covers a standby generator.

West and south elevations of the three bay equipment garage.

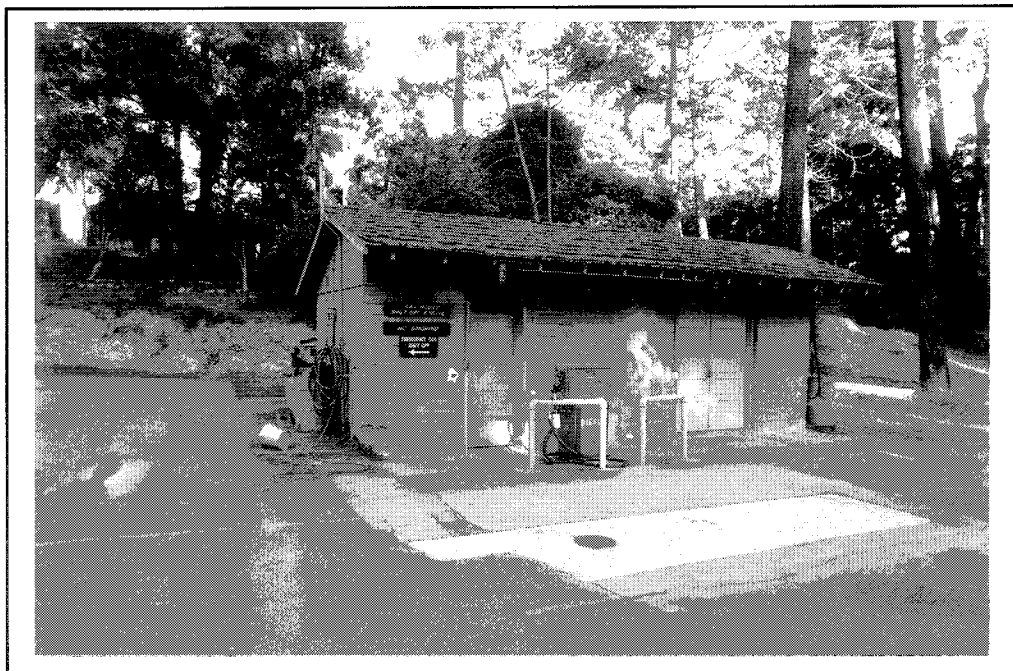
The gas and oil house is a 260 square foot rectangular building with a concrete slab foundation, open eaves, and wood shingles over a "saltbox" gable roof. The building consists of a 12' x 10' north room and a 14' x 10' south room. The rooms may be of different ages, with the oldest section dating from 1948. The east slope of the roof extends over a row of wood frame lockers. These tool lockers have been attached to the rear elevation of the building. The west slope overhangs the fuel pump island. The gable side entry for the north room has a single 5 panel door while the south room has double doors of the same design. A 4 light window is on the south gable end, three 4 light and two 6 light windows are located on the east elevation (covered by the added tool lockers). The fire station buildings are located on level ground which lies between a small hillside on the east and the Holman Highway on the west. The east and north ends of the property slope uphill, with a large upper level parking area located just north of the combination barracks. Landscaping of shrubs, pine and eucalyptus trees cover the site. A small lawn is on the north side of the barracks.

Front elevation of the gas and oil house.

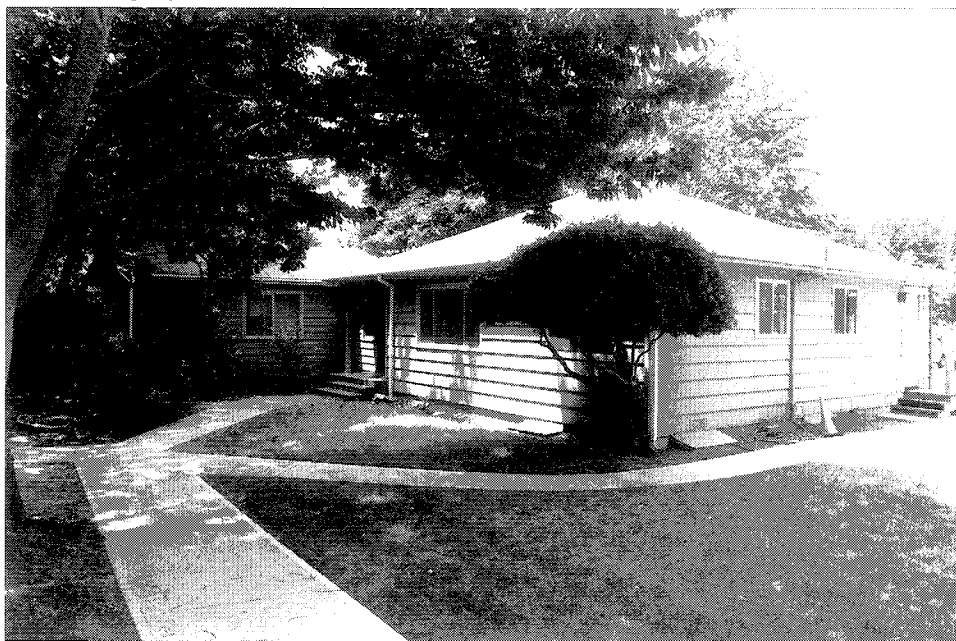
There are two buildings here which date from the CCC era. The former ranger's residence is a 1,677 square foot wood frame building erected in 1935. The residence now serves as an office building. It has a concrete perimeter foundation, lapboard siding, boxed eaves, and asphalt composition shingles over a hip roof with gable front wing. The house also has 1/1 aluminum frame sliding windows, and a combination of 1/1 and 1/1/1 metal frame casement windows. There is one 4 light wood frame window located at the north end of the west elevation to the right of which is a 1/1 sash window. The front door is located on a diagonal wall at the north end of the entry porch. The porch is recessed under the principal roof. The porch wall between the front door and a 6 light casement window to the left is covered with "v" rustic siding (arranged vertically). The gable front wing (added circa 1960) is at the south end of the east elevation. A louvered attic vent is centered in the "v" rustic clad gable. A 34' x 11' bay (under the principal roof) is on the north end of the west elevation. An internally accessed 14' x 16.5' poured concrete basement underlies the north end of the house. A brick chimney is situated on the north slope of the principal roof. The 2,752 square foot equipment garage was constructed in 1935. It has a concrete slab foundation, boxed eaves, and asphalt composition shingles over a gable roof. (See continuation page)

Northeast side of the former ranger's residence (forest practices office).

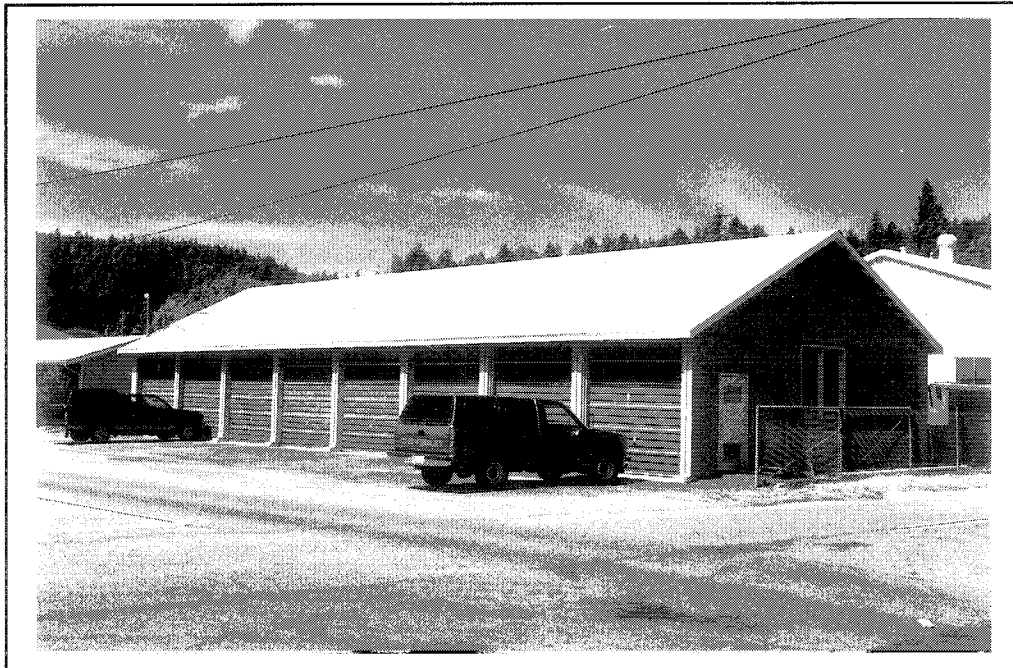
The equipment garage is a rectangular wood frame building with a 7' x 19.5' extended shed roof addition on the rear elevation. Plywood panel siding is on the north and east elevations of the garage with 10" "v" rustic siding on the south elevation and on most of the rear addition. The vehicle stall entries are on the east elevation and have overhead sectional fiberglass doors. Three panel "chevron" louvered attic vents are center at the apex in each gable. Channel siding covers each gable. Centered on each gable end are 15/15 wood frame windows. A row of five 6/6/6 wood frame (fixed and hopper) windows are across the rear (west) elevation with a 6 light window at the north end of this row.

East and north elevations of the eight bay equipment garage.

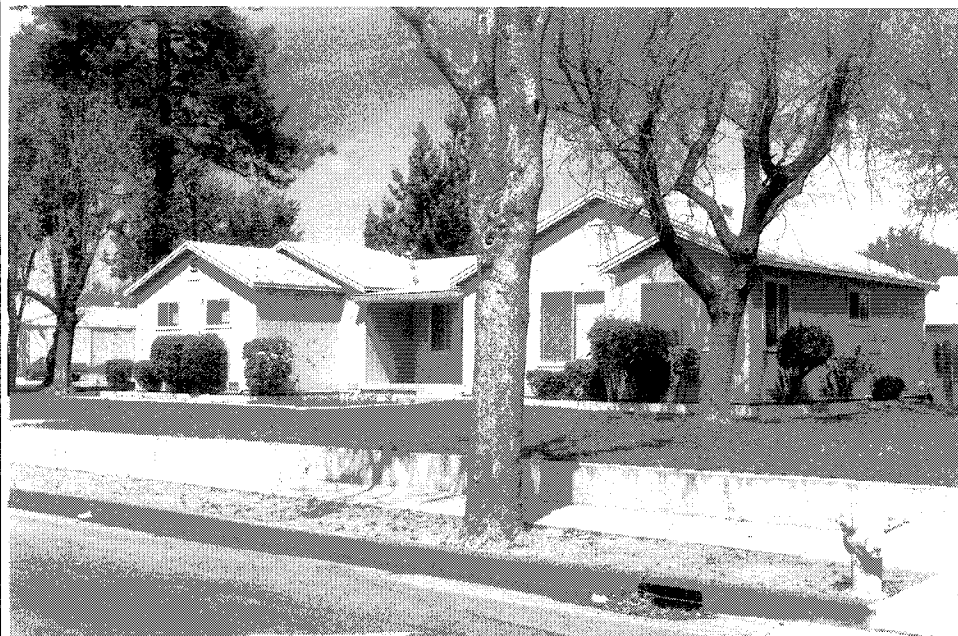
Included on this former ranger unit headquarters compound is a 1936 ranger's residence (remodeled circa 1953) and a 1937 equipment garage. The 1,634 square foot ranger's residence has a concrete perimeter foundation, plywood panel siding, 1/1 aluminum frame sliding windows, fascia, and asphalt composition shingles over a cross-gabled roof. The building has a compound floor plan with an asymmetrical front facing "U" design. Inset in the "U" under the principal roof is a 6' x 11' concrete front porch. On the gable end of the 19' wide left front wing is a 9' x 16' gabled bay. On the gable end of the 25.5' wide right front wing is a 3' x 9' gabled bay. The left front wing has a rear small hip on the ridge of the principal roof. The right front wing has a rear gabled wing with back door. Offset to the right end of this rear gable is a 7.5' x 14' gabled bay. Centered on the bay is a gable end stone chimney. An extended shed roof runs gable side along the northern elevation of the rear bay and rear wing. The roof covers an enclosed rear entry porch. A cantilevered shed roof covers the back door. The back yard is enclosed by a five foot high wood fence. To the southeast, on the outside of the fence is a 1963 residence garage. The seven bay equipment garage is a single story wood frame rectangular building with a 10' x 12 shed roof covered tool room located near the western end of the rear elevation. (See continuation page)

West and south elevations of the former ranger's residence (office).

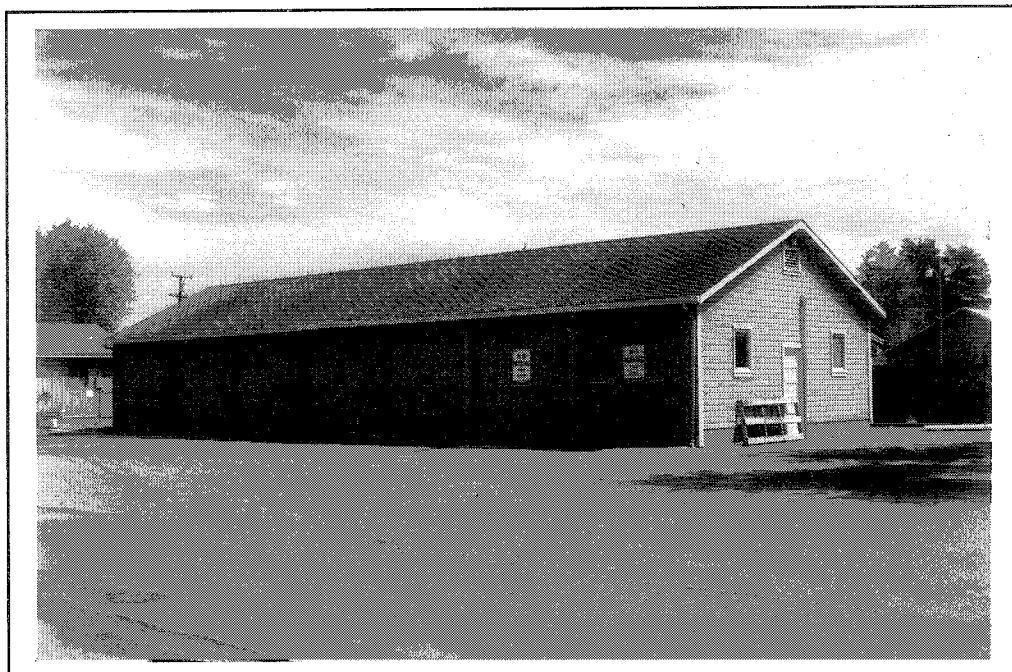
The 2,199 square foot building has a concrete slab foundation (concrete perimeter for the tool room), "v" rustic siding, plain fascia, and asphalt composition shingles over a gable roof. Rectangular single panel louvered vents are centered in each gable. The vehicle bay entries have the original cross-diagonal board overhead doors. A "v" rustic (vertically arranged) clad door is integrated into the east end bay door. Centered on the west gable end is a 5 panel door flanked by a single wood frame window on each side (original 4 light converted to 1 pane). The east gable end has four single pane wood frame windows symmetrically arranged across this elevation. A single batten runs between each window. A row of single pane wood frame windows is across the south elevation. One window is to the right of the tool room, seven windows are equally spaced to the left of the tool room with a single batten in between each one. A row of six common casement windows fills the balance of the wall at the east end. The tool room has 4 light wood frame windows on the east and west walls with a 3 panel door centered on the south side.

North and west elevations of the seven bay equipment garage.

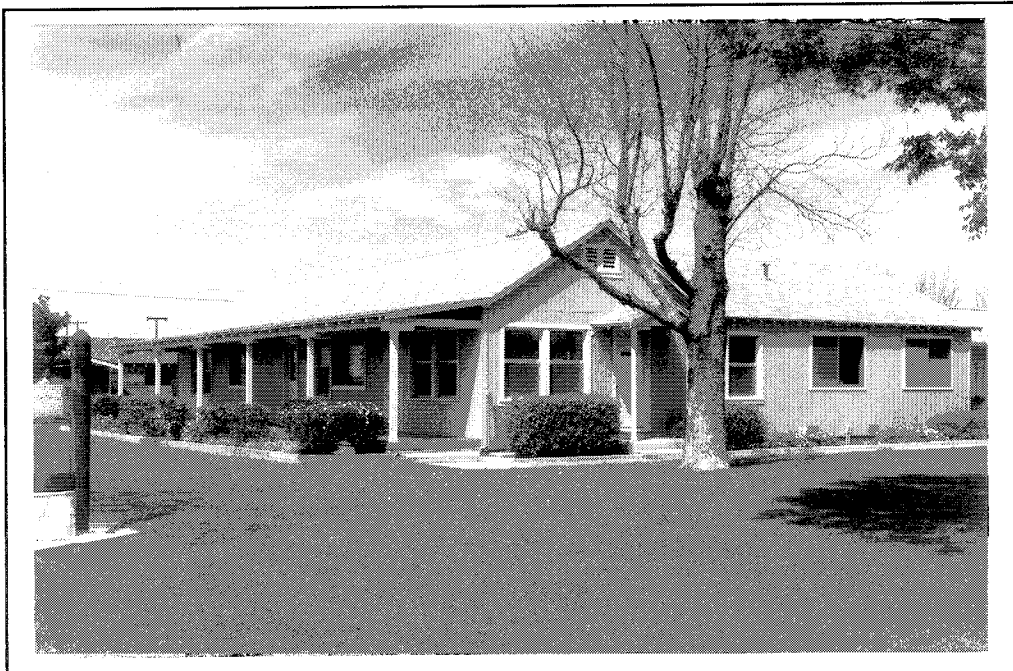
The property records are somewhat vague but the original 1937 office at this site was either replaced or substantially rebuilt in 1950. It was remodeled and enlarged again circa 1972. The 2,457 square foot building has a concrete perimeter foundation, plywood panel siding, open eaves, and asphalt composition shingles over a cross-gabled roof. Louvered attic vents are centered in each of the four gables. The building has a rear facing "U" floor plan. A combination of 1/1 aluminum frame sliders and 1/1 aluminum frame single hung windows are on the front wall. A full width extended shed roof covers a 6.5' x 63' concrete slab entry porch on this elevation. The porch roof is supported by six chamfered posts that have capitals. On the south gable end of the front wing is a gable roof covered side entrance. The side entrance roof is supported by two chamfered posts that have capitals. Centered on the north gable end of the front wing are three 1/1 aluminum frame sash windows. The rear wings have a combination of 1/1 aluminum frame sliders and 1/1 aluminum frame single hung windows. Shed roof covered side entrances are located gable side on the north and south elevations of the north rear wing. A rear entry porch is recessed under the northeast corner of the south rear wing. A shed roof covered utility closet is inset in the "U" on the rear elevation of the front wing. A concrete patio fills the area between the rear wings.

West and south elevations of the administration office.

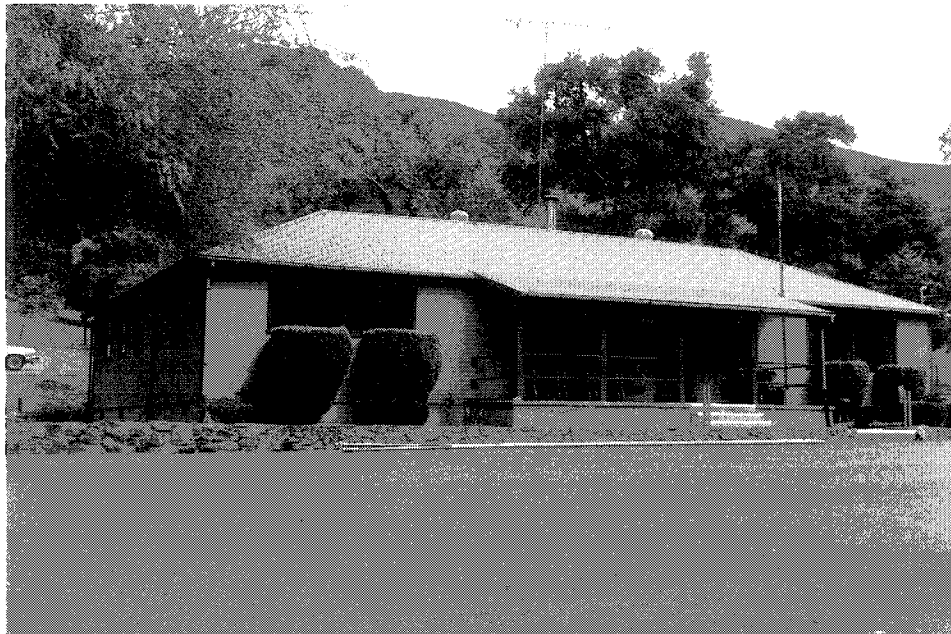
The 2,157 square foot combination barracks at this station was constructed circa 1942. The single story wood frame building has a concrete perimeter foundation, plywood panel siding, 1/1 aluminum frame sliding windows, boxed eaves, and asphalt composition shingles over a hip roof with gable rear wings. The building has a symmetrical "U" floor plan. An extended shed roof centered on the south elevation covers a 7' x 28'5" concrete front porch. The porch roof is supported by five chamfered wood posts. A side entry is on the east elevation of the right rear wing. Inset in the "U" at the corner junction of the left rear wing with the front wing is a rear entry. An extended shed roof from the north slope of the front wing covers this rear entry. To the east is a north wall utility door. Landscaping of lawn, shrubs, and trees has been put in around the combination barracks. To the east is a 1961 "v" rustic clad well pump house. To the west is a 1953 "v" rustic clad combination two bay equipment garage and storeroom, and a "v" rustic clad one-pump gas and oil house. State Highway 152 runs across the front of the property. The surrounding area is covered with a mixture of oak woodland, open range, and brush.

West and south elevations of the combination barracks.

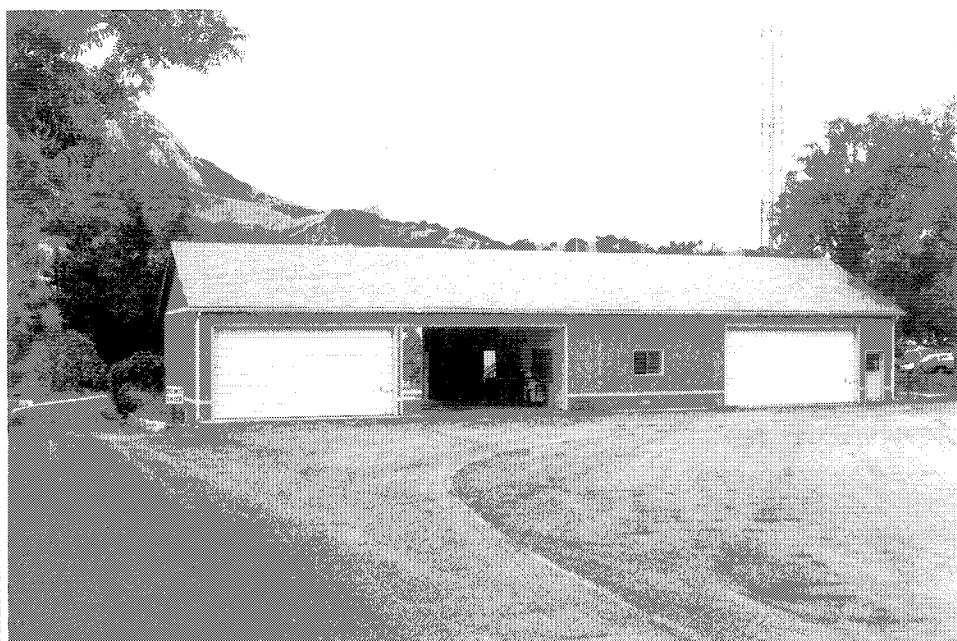
The equipment garage, ranger's residence, residence garage, and office were all originally constructed circa 1939. The 2,700 square foot equipment garage has been extensively remodeled. It is a single story rectangular wood frame building with a concrete slab foundation, plywood panel and batten siding, 1/1 aluminum frame sliding windows, open eaves (with rain gutters), and asphalt composition shingles over a gable roof. The three vehicle stall entries on the east elevation have 10' x 20' overhead aluminum sectional doors. The two vehicle stall entries on the west elevation have 10'3" x 11'9" overhead aluminum sectional doors. These two bays are "pull through" stalls. A two panel rectangular louvered attic vent and a belt coarse are on each gable end. The 1,408 square foot residence is a single story wood frame building with a 13' x 16.5' poured concrete basement. The building has a compound floor plan with a concrete perimeter foundation, "v" rustic siding, fascia, and asphalt composition shingles on a cross-gabled roof. Divided light double hung wood frame windows are featured on all elevations. The building has a central (gable front) wing, a left (west) wing, and a right (east) wing. The left wing is at the north end of the west elevation of the central wing. The right wing is centrally located on the east elevation of the central wing. A large, 8 light fixed pane window is centered on the south gable end of the central wing. (See continuation page)

East side of the former 8-bay truck garage (combination office and equipment garage).

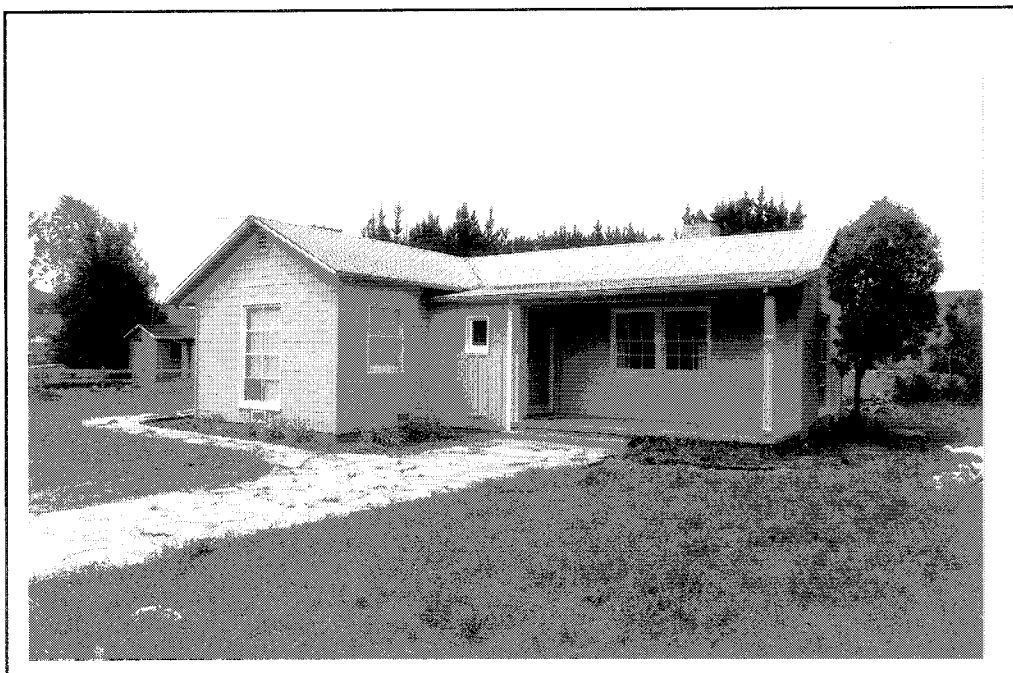
Southeast side of the former ranger's residence (office).

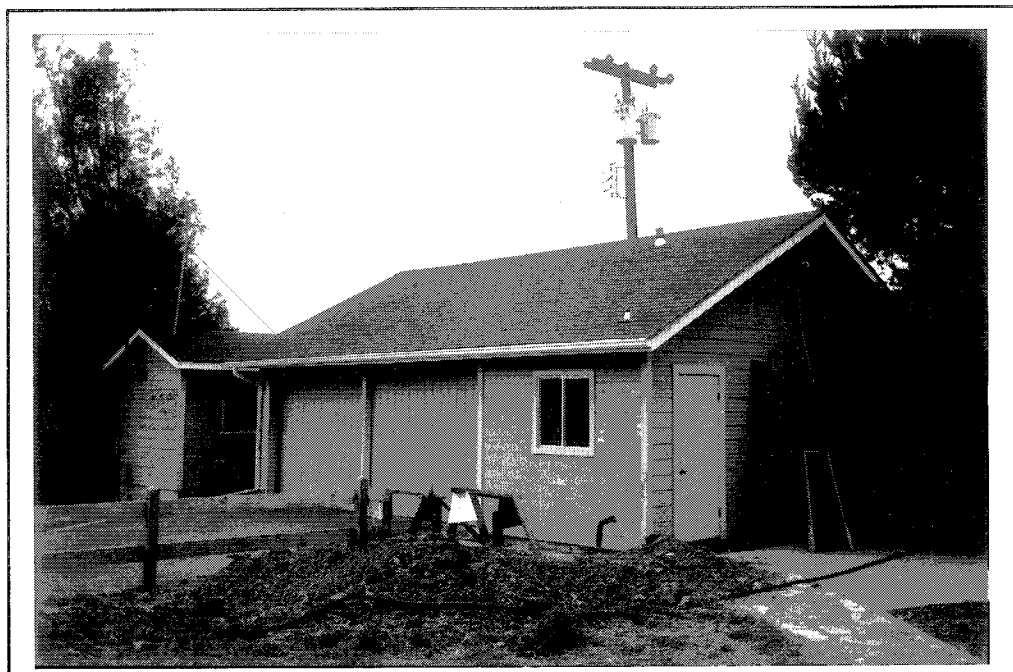
South and east elevations of the residence garage.

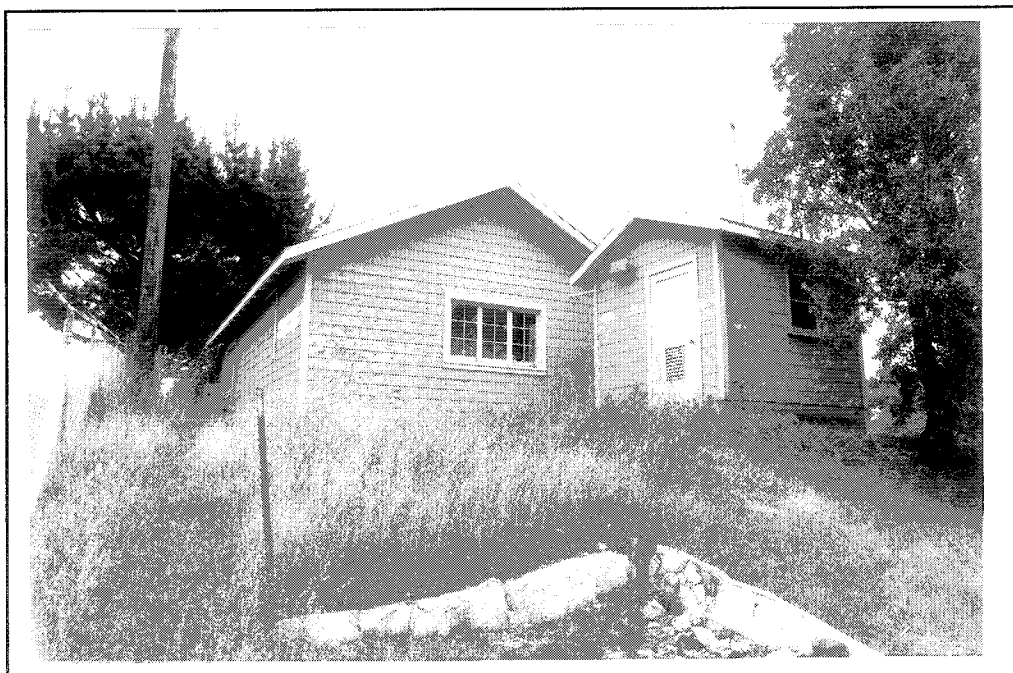
Northwest side of the generator house (residence garage on left).

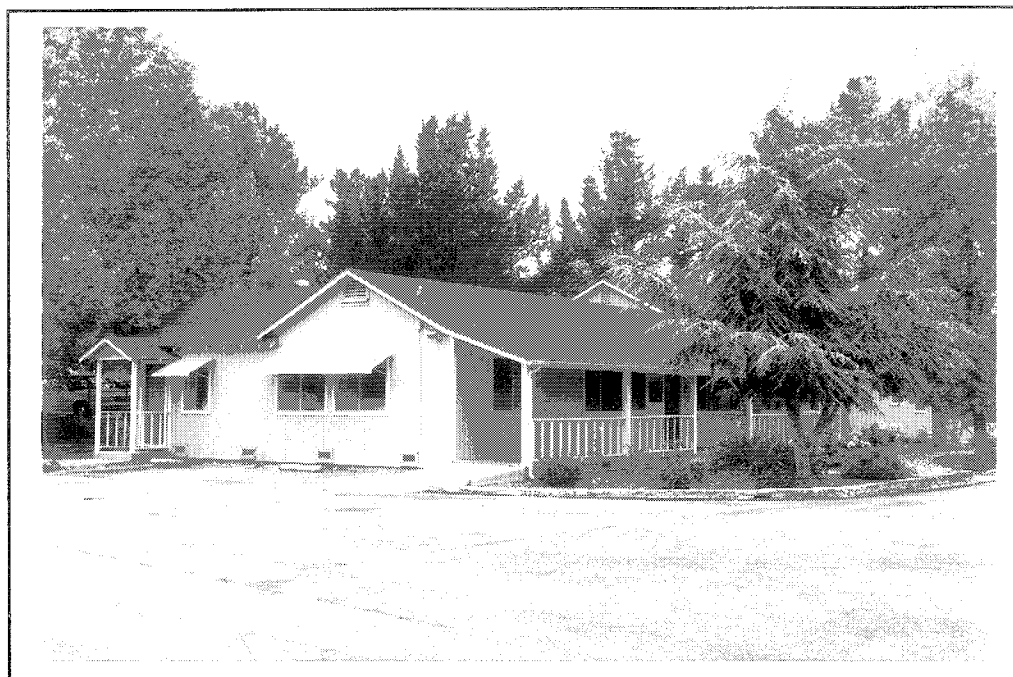
The original 18' x 30' office (erected circa 1939) was rebuilt into a 24' x 60' gable roof covered building in 1949. A 14' x 16' gabled wing was added on the west elevation near the south end in 1960. In the mid-1970s a 33' x 50' gable wing was constructed on the north gable end. The building was remodeled and enlarged again in the mid-1980s. The approximately 3,740 square foot building has a roughly rectangular shape with a two unit principal roof and three rear facing gable roofs (across the west elevation of the 24' x 60' older office area). This building has a concrete perimeter foundation, pressed hardboard siding, 1/1 aluminum frame sliding windows, plain fascia, and asphalt composition shingle roofing. The main entry is located gable side. The 6' x 60' concrete front entry porch is covered by a shed roof supported by six wood posts. Cantilevered awnings shade the south elevation windows. A gable roof covered side entry is to the left of these windows. Awnings are also over the west elevation windows. Two shed roof covered utility closets are on this side and rear entries are covered with either shed or gable roofs.

Southeast side of the administration office.

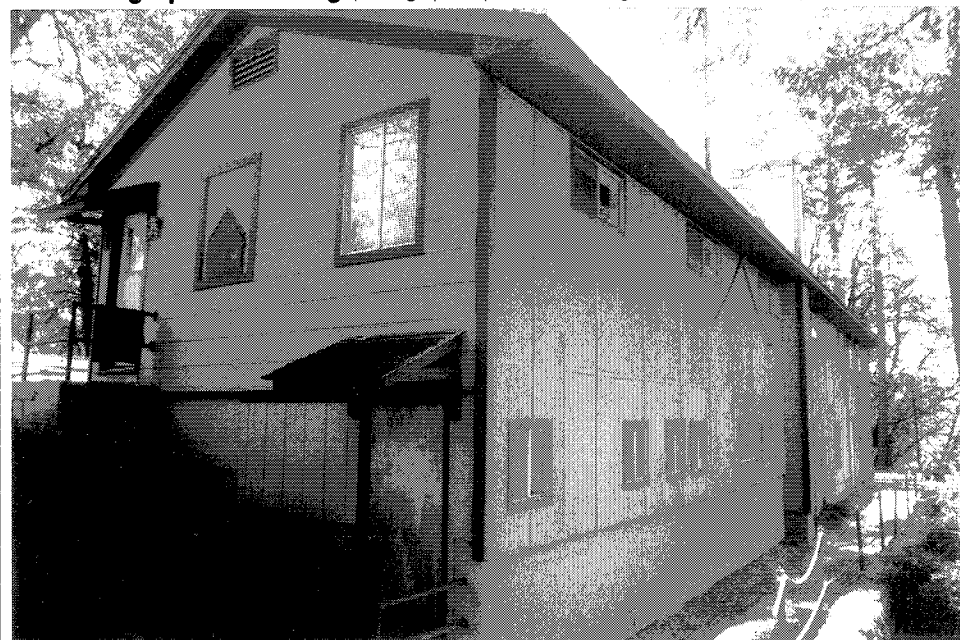
The barracks, combination kitchen-messhall, and equipment garage at this site were constructed circa 1938. The barracks and kitchen-messhall are split level buildings with the upper level serving as the main floor. The 3,100 square foot barracks is a wood frame rectangular building that has a combination concrete perimeter and slab foundation, 1/1 aluminum frame sliding windows, boxed eaves (with rain gutter across the front), and asphalt composition shingles over a gable roof. The front entry for the upper floor is at the left end of the northwest gable end. A small concrete landing (with hand rails on the downhill sides) is in front of this door. A cantilevered wood shingle shed roof protects the door. The window to the right of this entry has had the glass removed. The space has been framed in and a decorative panel of a building silhouette installed within the casement outline. A cantilevered wood shingle shed roof is over a lower level entry at the right end of this same elevation. A 21.5' x 20.5' split level addition has been constructed on the southeast gable end of the original barracks. The addition is clad with plywood panel siding. A 4.5' x 5' uncovered concrete porch and gable side entry is located on the northeast elevation of this addition. A lower level door is located gable side on the southwest elevation. The rear (southwest) elevation of the original barracks has a gable side boxed stove pipe. (See continuation page)

Northwest and southwest elevations of the barracks.

The rear wall of the original barracks is covered with plywood paneling and widely spaced batten. The other two outside walls of the original barracks have 12" "v" rustic siding. An internal stairway on the northwest gable end connects the two levels. The upper level contains sleeping quarters and rest room. The downstairs contains a locker room, exercise room, and office-storage area. Concrete walks extend across the front and rear elevations.

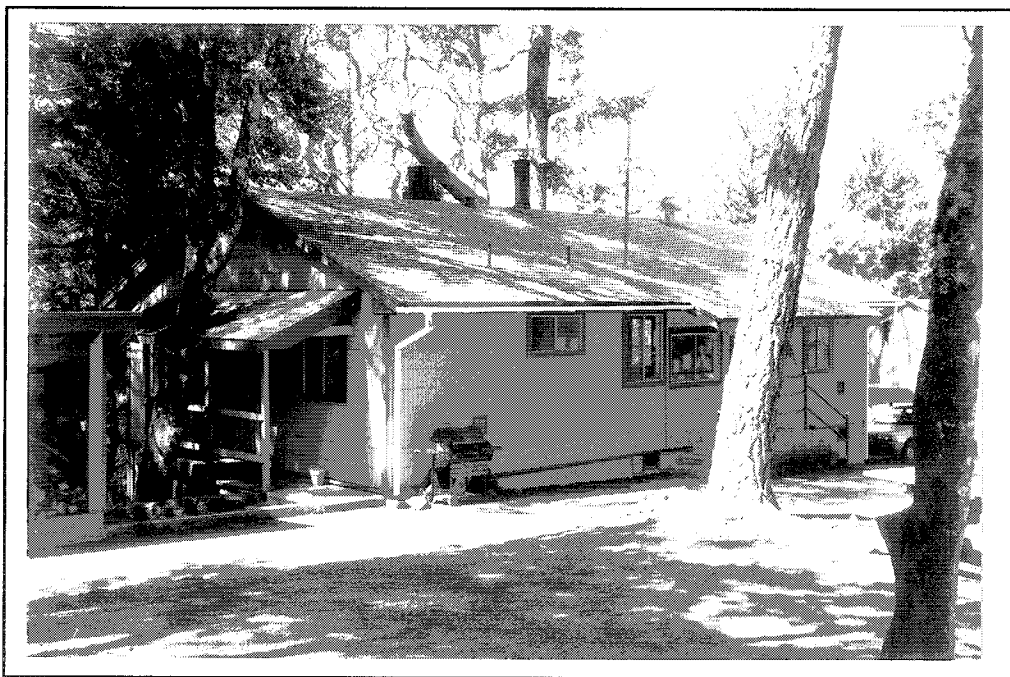
The 2,310 square foot kitchen-messhall has been remodeled and now includes the station office. Only a portion of the ground floor of the kitchen-messhall has been finished. It serves as a small combination basement and tool room. The rectangular wood frame building has a combination concrete perimeter and slab foundation, 1/1 aluminum frame sliding windows, boxed eaves (with rain gutter on the front), and asphalt composition shingles over a gable roof. The side gable front entry is recessed under a diminutive cantilevered extended shed roof. A shed roof covered porch is on the southeast gable end. The porch roof has been cut to fit around a large oak tree. The roof is supported by wood posts. The lower level entry is at the left end of this elevation. A 2/4 sash window is to the right of the lower level door. A stone and cement stairway leads from the lower level to the upper level at this end of the building. Plywood panels and widely spaced batten cover the rear elevation of the building. The other three walls have 12" "v" rustic siding. There is a stone wall running behind both the barracks and the kitchen-messhall. An open front, wood shed is between the barracks and kitchen-messhall on the upper level.

Southeast and northeast elevations of the office-kitchen-messhall.

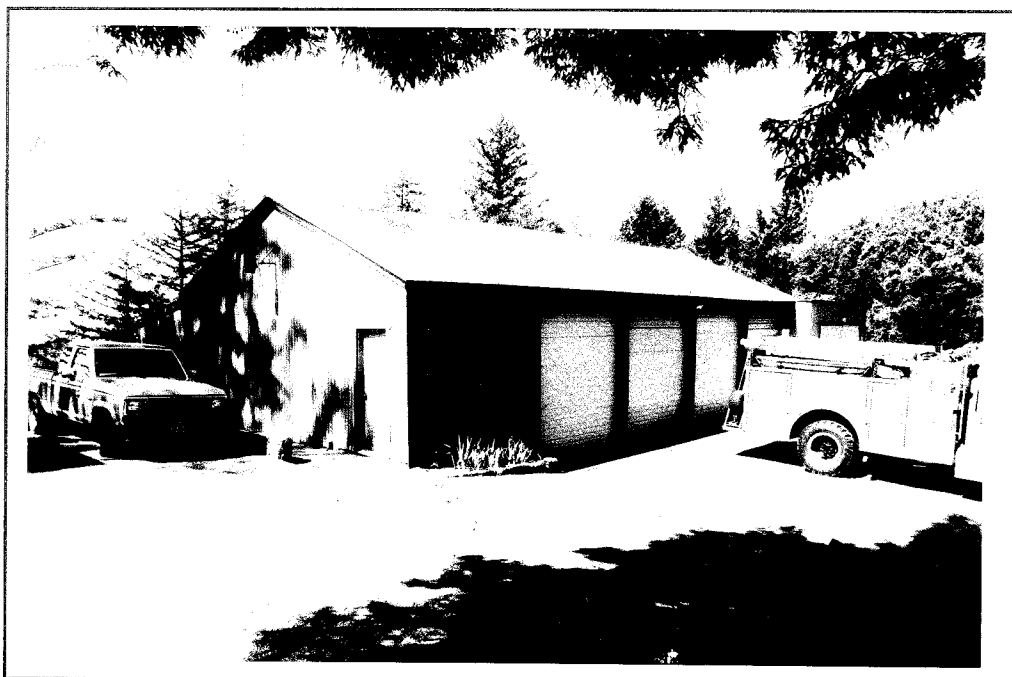
The 2,025 square foot equipment garage is a single story wood frame building with a concrete slab foundation, plywood panel siding ("v" rustic in the northwest gable), and asphalt composition shingle roofing. The building consists of the original garage and two additions. The original garage is a rectangular building with gable roof and enclosed eaves. Its floor plan consists of a combination four vehicle stall garage and one room storage (at the southeast gable end). A 17' x 11.5' addition has been constructed at the southern end of the southwest elevation of the original garage. The addition has a plain fascia and shed roof. Another addition has been constructed on the northwest gable end of the original garage. This 18' x 28' addition has a flat roof with diagonal parapet on the rear, open eave on the side, and false front. This addition's front wall is about three feet forward of the adjoining front wall of the original garage. The four vehicle entries on the original garage have overhead aluminum sectional doors. The vehicle entry for the northwest addition has a hinged double door. The storeroom on the southeast end of the original garage has a 1/1 aluminum frame sliding window on the front wall and a side door on the southeast wall. Three 1/1 aluminum frame sliding windows are across the rear elevation of the original garage.

Southeast and northeast elevations of the equipment garage.

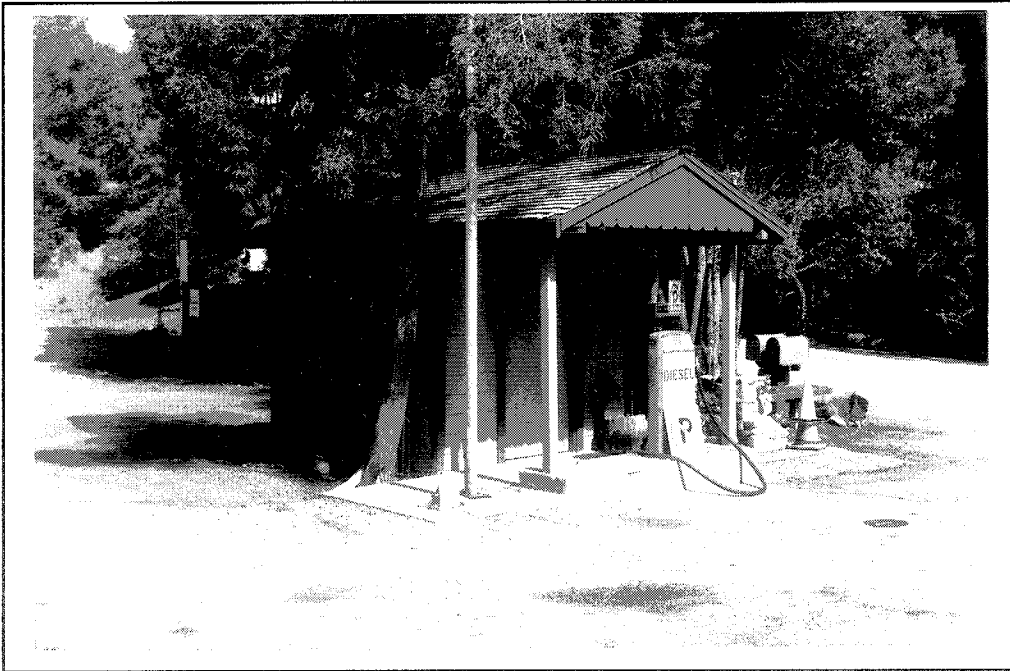
In front of the garage is an 80 square foot gas and oil house. The building may be a reconstructed 1930s service station or a totally new building dating from circa 1968. It has a concrete slab foundation, 8" "v" rustic siding, plain fascia, and wood shingles over a simple gable roof. The 2' x 8' fuel pump island is recessed under the front gable. The roof overhang is supported by two wood posts. The original door has been replaced, the building has no windows, just a screened vent above the door. The compound is located along a summit ridge. The area is covered in native oak, fir, and madrone with some under story brush. The barracks and office-kitchen-messhall face the summit ridge. On the other side of the summit is Skyline Boulevard. The equipment garage is north of the crew quarters and has an unobstructed view of the boulevard.

Southwest and southeast elevations of the gas and oil house.

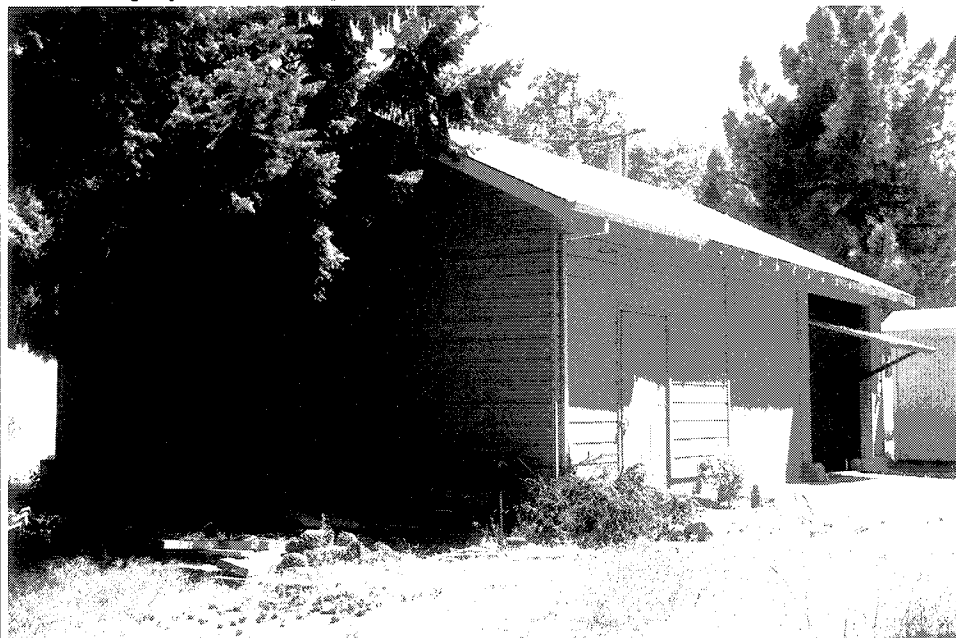
North and west elevations of the "old" truck garage.

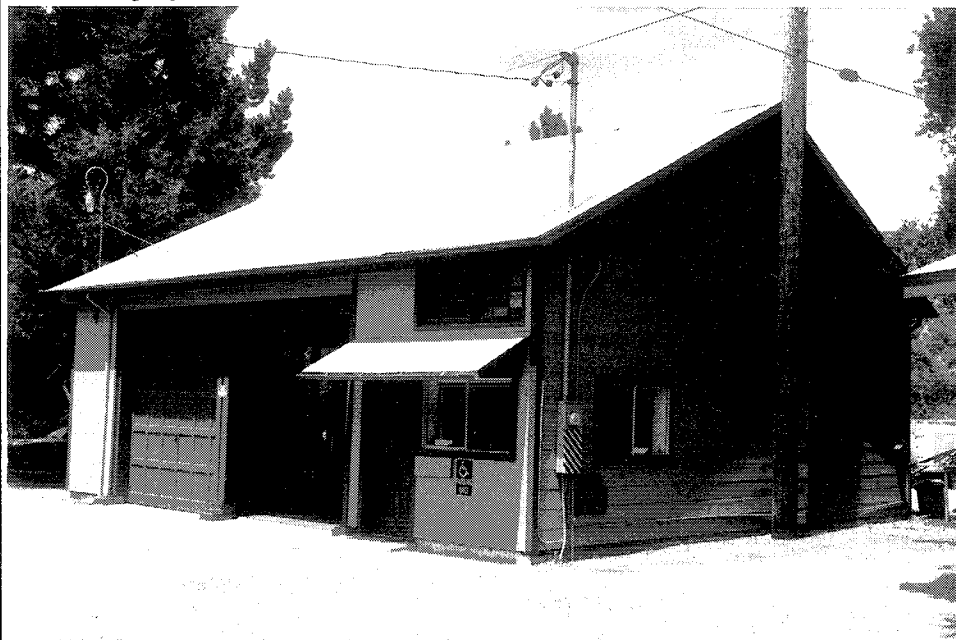
Western and southern elevations of the combination office and truck garage.
